**TRANSPORTATION SCIENCES CENTER  
ACCIDENT RESEARCH GROUP**

**CALSPAN ON-SITE AIR BAG DEPLOYMENT INVESTIGATION  
CALSPAN CASE NO. 95-16  
VEHICLE: 1995 FORD ESCORT LX, STATION WAGON  
LOCATION: [REDACTED] PA  
DATE OF CRASH: [REDACTED] 1995**

Contract No. DTNH22-94-D-07058

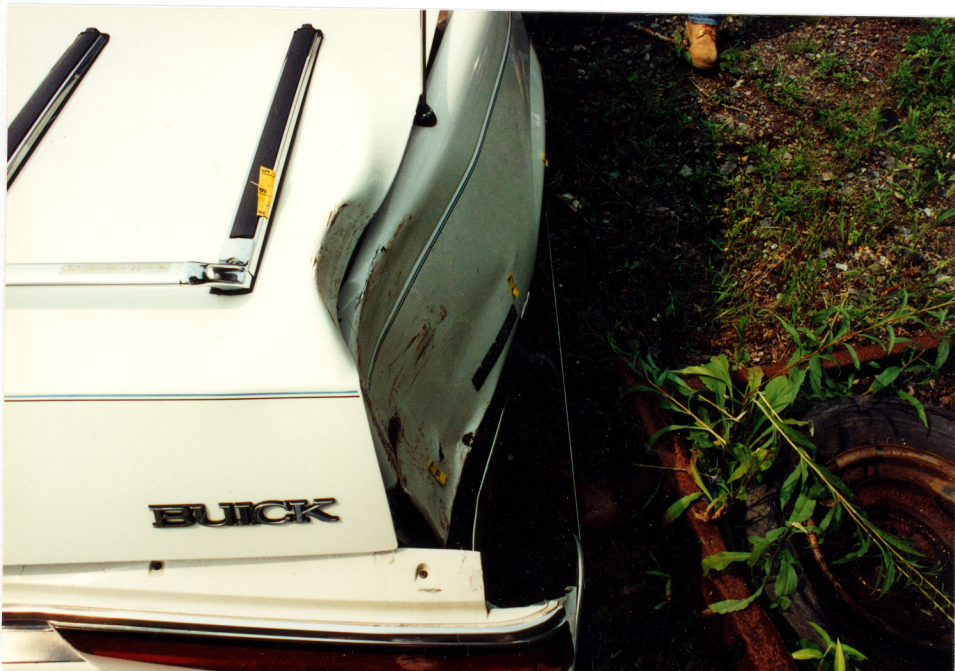
108. Close-up view showing the extent of right side crush.

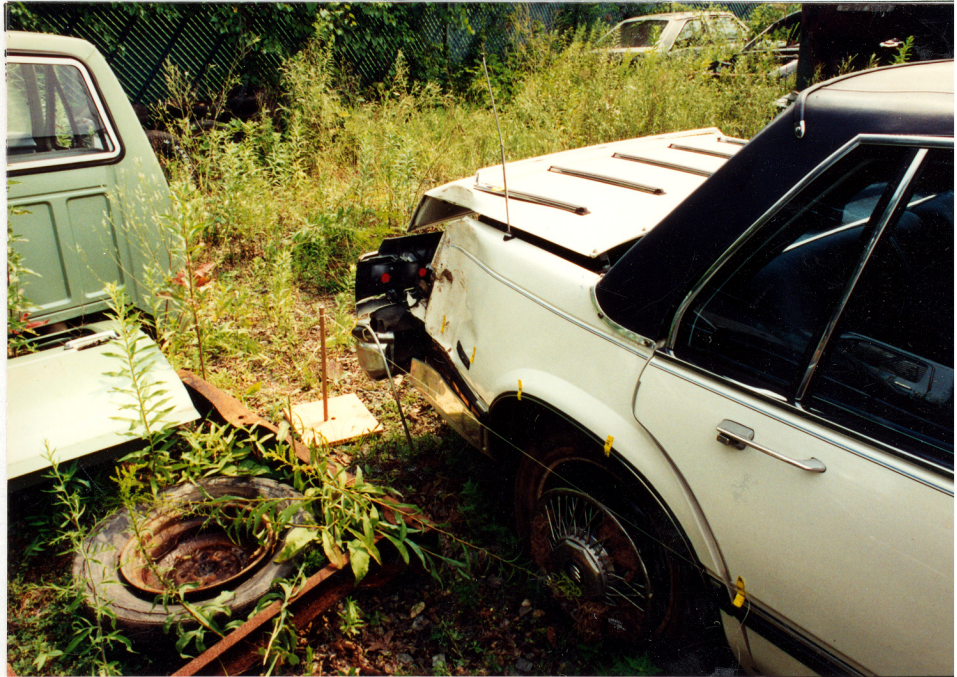
109. Overall view of the pole impact damage.
